SPRING 2005

# Flight Comment

- *Metal Fatigue — It's Got a Bad Name*
- *Predators on Patrol*
- *Communications During Aircraft Ground Deicing Operations*

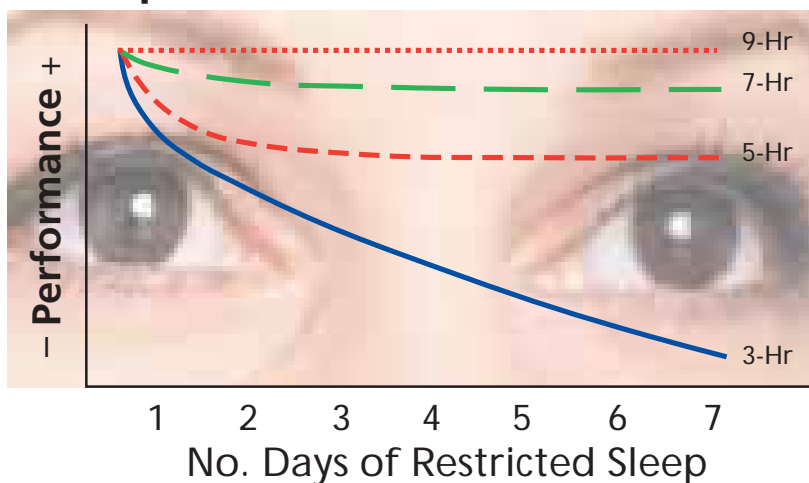
## Sleep Restriction vs. Performance

For individuals consistently running on 5 or 6 hours of sleep, take note: Recent studies indicate human performance drops off significantly, and then stabilizes at a lower level following mild (7-hour sleep period) and moderate (5-hour sleep period) sleep restriction. Experts caution that 5 hours of sleep per day is the absolute minimum and should not span more than 14 consecutive days ... or rule # 2 may kick in!

Adapted from: "Patterns of performance degradation & restoration during sleep restriction and subsequent recovery: a sleep dose-response study" Belenky et al., J Sleep Res. Vol. 12:1 Mar 2003.

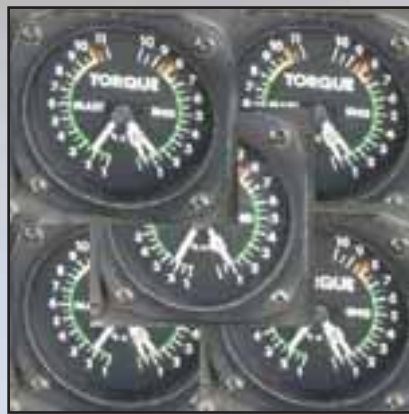
*A collage of Griffon torque gauges showing “the split” — not exactly representative of flight conditions but you get the idea.*

The *Griffon's* co-axial engine torque needles need to be carefully monitored to ensure that the engines stay on condition with each power change (the manually controlled engine about 5% below the automatic; commonly referred to as

“the split”). In the blink of an eye the two torque needles can overlap or even swap positions if there isn't a throttle reduction with every reduction in power to the main rotor.

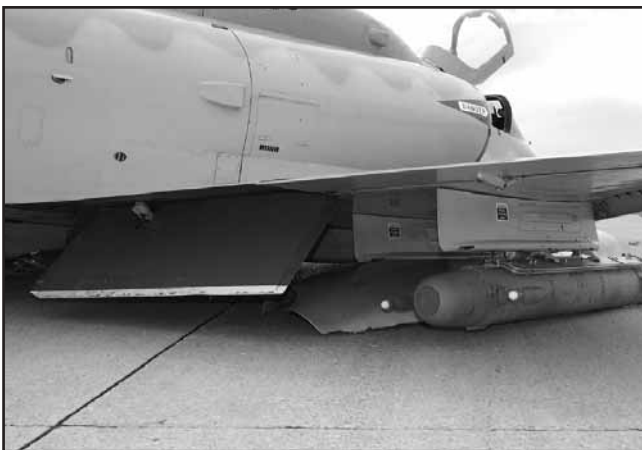
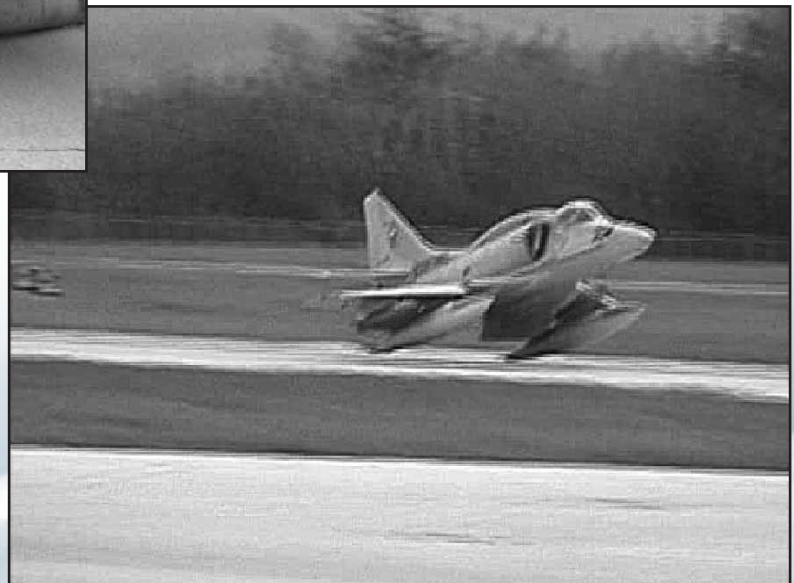
The pilot in number 2 was distracted by a radio communication problem and failed to lower the gear. The aircraft landed gear up and crossed the arrestor cable slicing the external fuel tanks in half.

The aircraft continued down the centerline of the runway showering sparks underneath the ruptured tanks. No fire developed, and the aircraft came to a stop with approximately 6000' of runway remaining. The pilot shut down, egressed from the aircraft and waited for the emergency vehicles to arrive. Emergency response vehicles were on scene quickly and the site was secured. The aircraft received "D" category damage. There were no injuries.

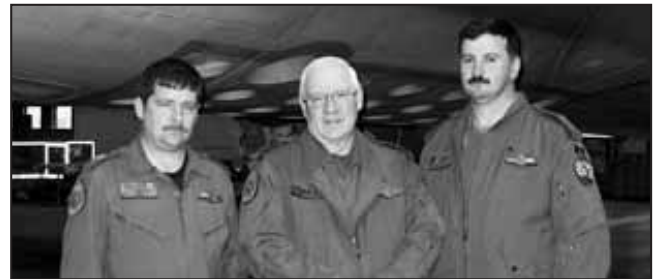
Upon carefully assessing the situation, a cargo strap was located and slid down the PSLT, between the wall of the PSLT and the side of the sonobuoy. The sonobuoy was slowly raised the 3 feet back into the aircraft. With the sonobuoy removed from the PSLT the aircraft returned to base without further incident.

At the end of a routine maritime patrol, an *Aurora* crew attempted to launch a sonobuoy; a procedure that occurs on almost every mission. However, while attempting to launch a sonobuoy from the pressurized sonobuoy container (PSLT) #2, the crew heard an unusual sound. Upon inspection, the crew carried out the misfired cartridge actuated device procedure, and eventually removed the sonobuoy launch container from the PSLT. Further investigation revealed that the sonobuoy itself was jammed in the PSLT due to the malfunctioning of the lower exterior door.
